### Prediction of Service Life and durability analysis of Pier Structure

A durability investigation of a 30 year old barge pier structure located in a tropical marine environment was carried out. Preliminary as well as a detailed visual inspection of the structure was carried out in order to a) identify the different types of defects, b) estimate the extent and coverage of defects on the barge pier structure and c) decide the types of field and laboratory tests to be conducted and the extent of sampling. The important observations noted during the visual inspection were:

By Fong Weng Khiong (fongwk@ascenfe.com) Ascent Facilities Engineering Pte Ltd, Singapore

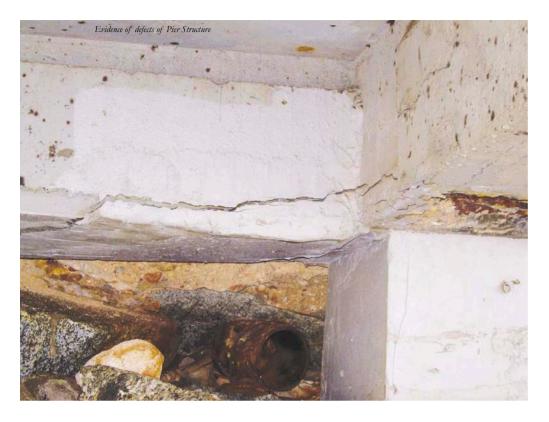
- · Almost all the major defects were found to be located under the barge pier structure. The top surface of the concrete deck of the barge pier had no apparent defects except for abrasion wearing of the concrete surface.
- No other/excessive loading was noted on the barge pier except for pipes transferring waste oil to the island.
- · Spalling of concrete was noted as the most common defect occurring at the beams and the slab. The spalling was noted at various stages from development of crack lines to spalled patches. This can be seen in Figures 1. Rusty reinforcement was exposed at some areas where the concrete cover had spalled off. At locations where previous repairs were found to have been carried out, the boundary of the patch repairs had started to crack and spall due to the expected phenomenon of macrocell corrosion. Figure 2 shows the occurrence of cracking.

The rehabilitation solution for the pier structure was designed to suitably address the defects observed during the investigation. The necessary "immediate reactive" repair methods were proposed to address the defects that merited instant attention. This involved i) delaminated/spalled concrete repairs using the patch repair method, ii) repairs to cracks using epoxy resin injection, iii) strengthening of beams by increasing their sections size and reinforcement or by the use of fiber reinforced polymer laminates with moisture tolerant epoxy resins, iv) strengthening of the steel piles by welding additional plates and v) application of protective coating on the steel piles using a high build epoxy material.

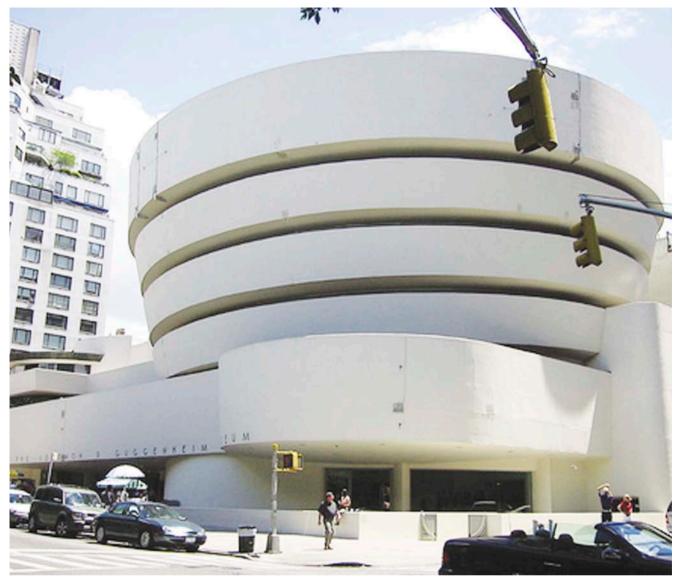
2007-2008: repairing of certain sections of the Museum's circular outside facade using PLANITOPXS mortar.
